Root Director

RootDirector C Series

Modular Root Management Device for Urban Trees

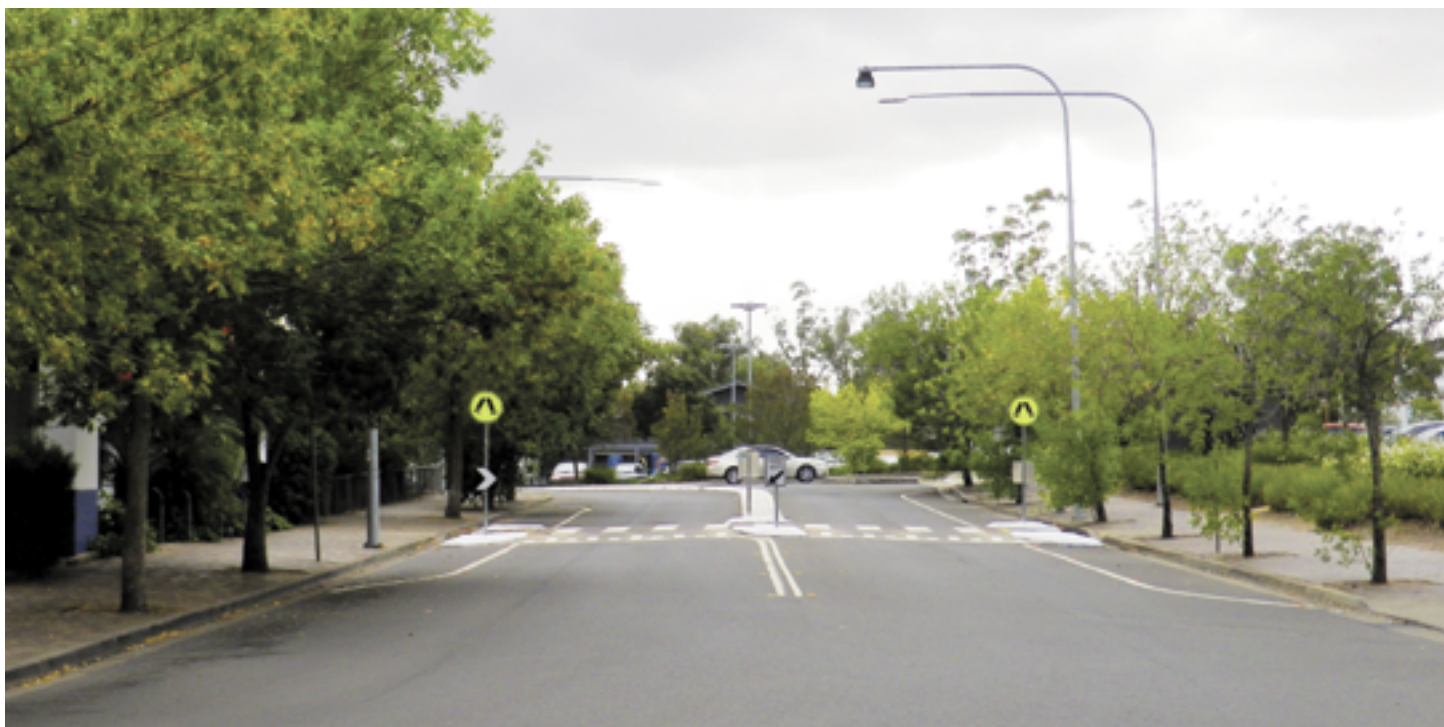
Sydney, Australia utilizing root directors – allowing the trees to grow larger and healthier without disturbing the surrounding pavement structure.

A Sydney Australia project encapsulates the benefit of root directors. Above is a photo of mature trees growing in Sydney, some with root directors and some without. Planted around the same time it is clearly evident the success of the root directors in providing healthy tree growth.

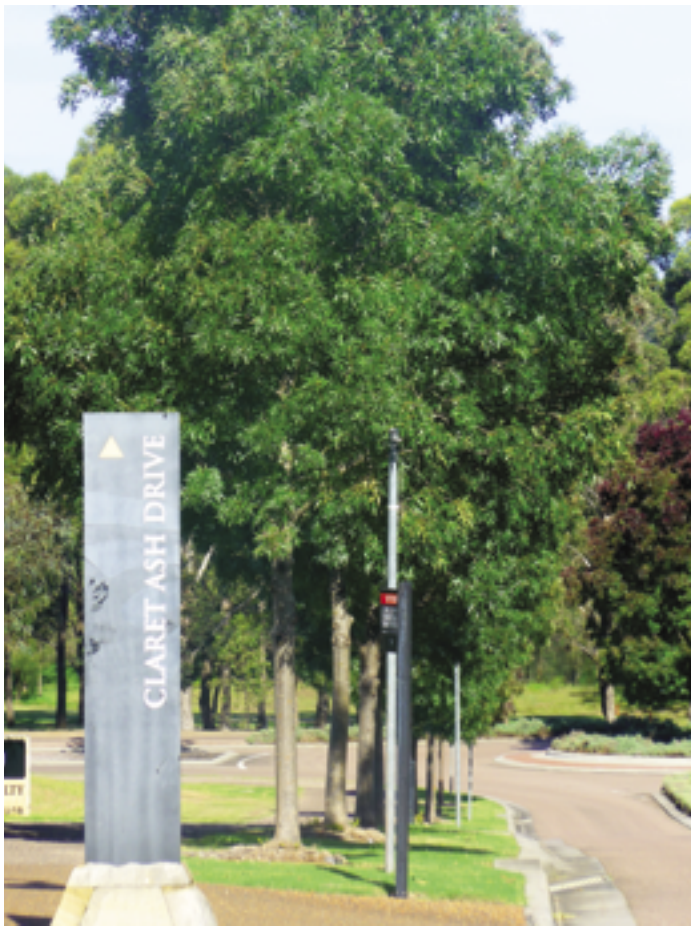
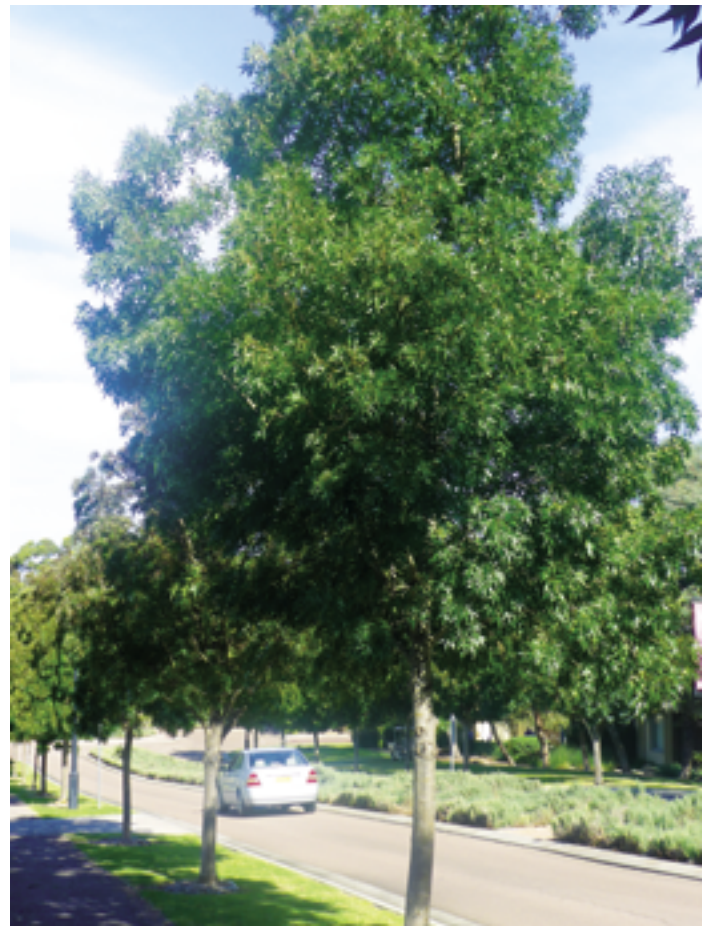
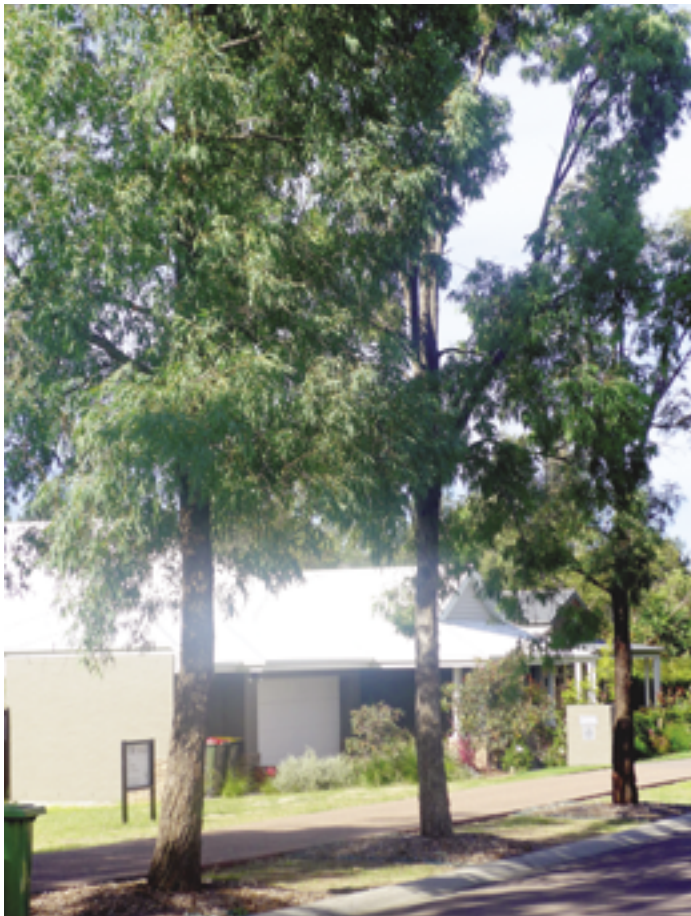
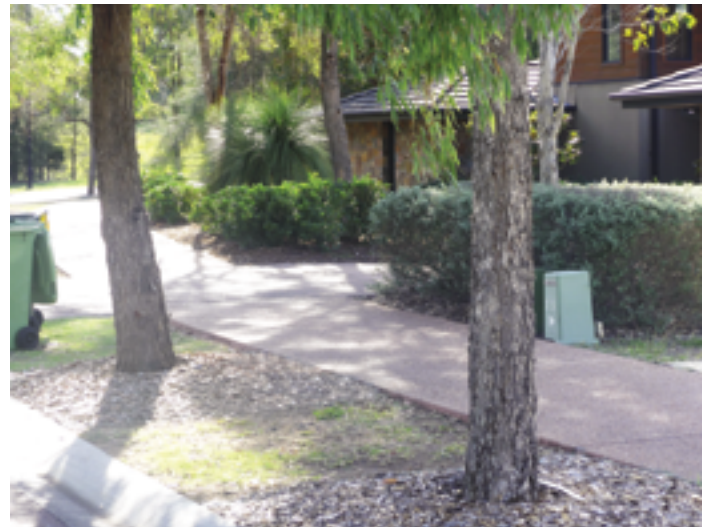
The new Citygreen root director C series carries the original benefits of the RD640 root director but now also includes and integrated circular lawn edge at the top surface for a neat finish to projects.

The Vintage Estate is a high class estate located in the Hunter Valley, NSW, Australia. Root directors were used in this estate and subsequently the trees have flourished.
