# Root Directors

A compact, cost-effective solution for urban tree installation

# RootDirector

## Modular Root Management Device for Urban Trees

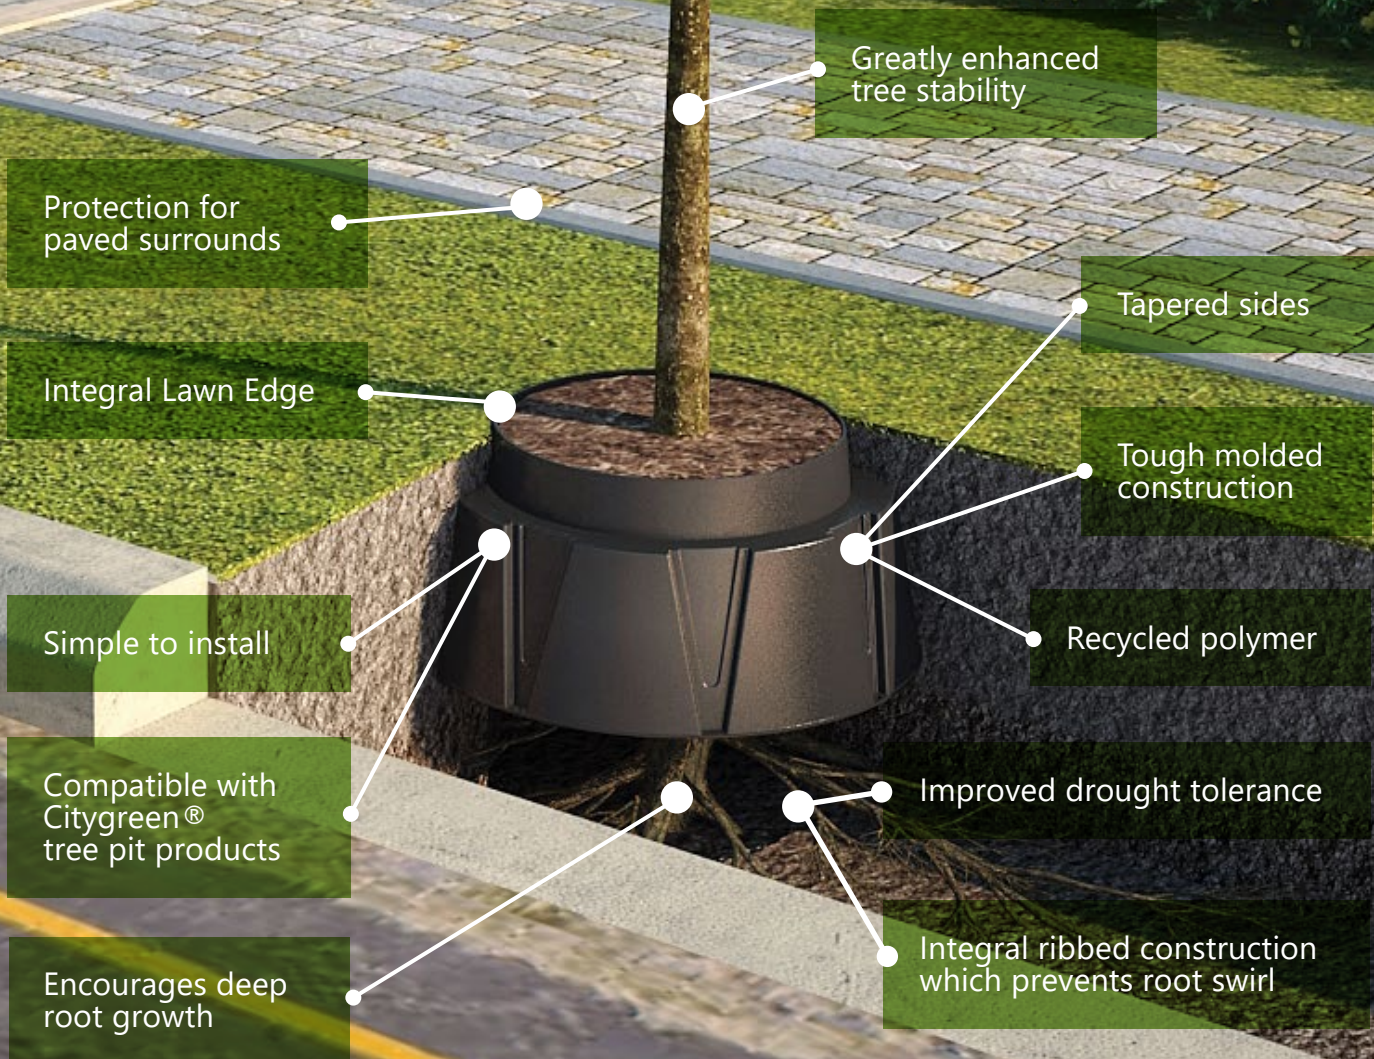
# Benefits

Root Directors are designed to divert roots down for protection of pavement, and out for stability and health of the tree.

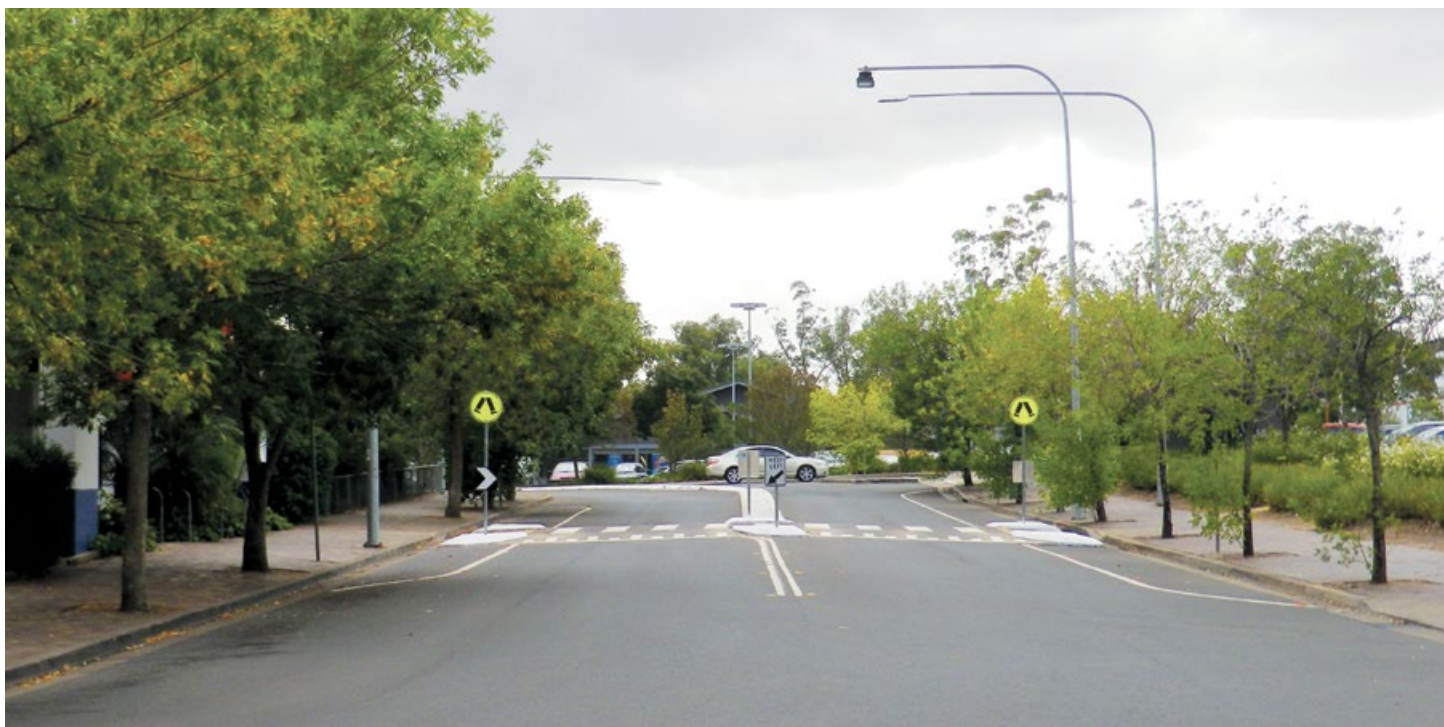
Sydney, Australia utilizing root directors – allowing the trees to grow larger and healthier without disturbing the surrounding pavement structure.

A Sydney Australia project encapsulates the benefit of root directors. Above is a photo of mature trees growing in Sydney, some with root directors and some without. Planted around the same time it is clearly evident the success of the root directors in providing healthy tree growth.

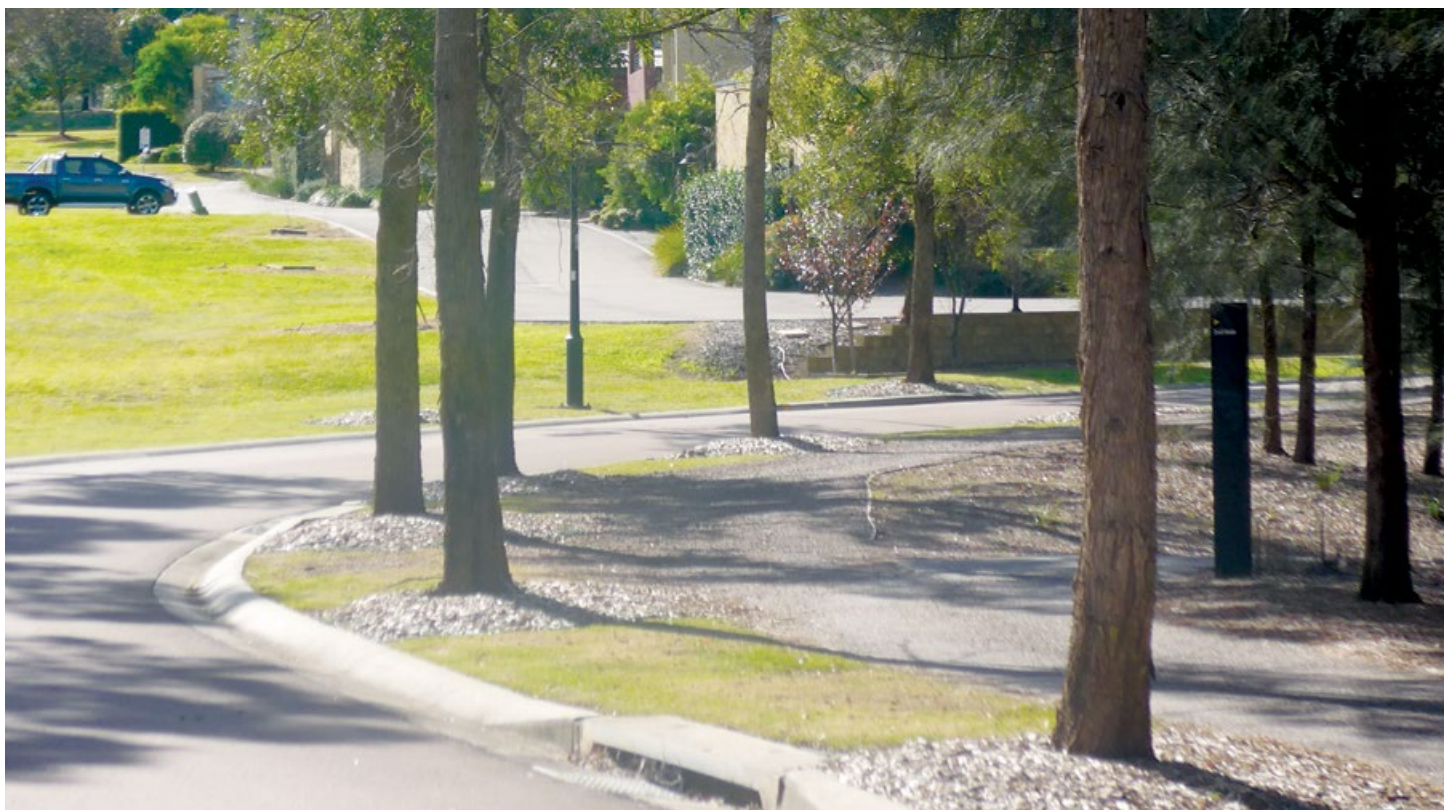
Healthy native species in residential estate planted in root directors. Zero damage to curb or sidewalk.

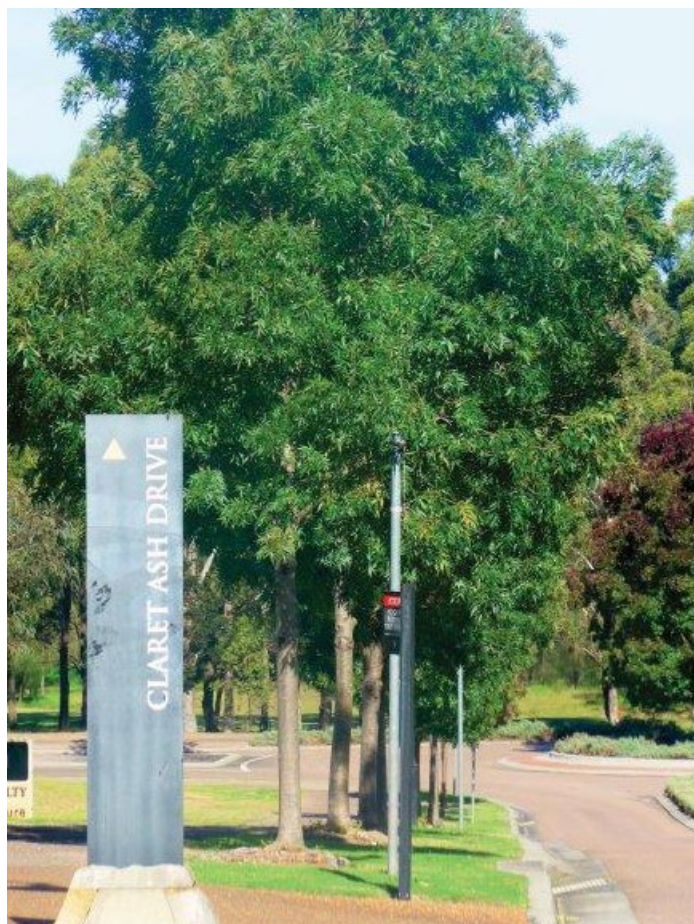
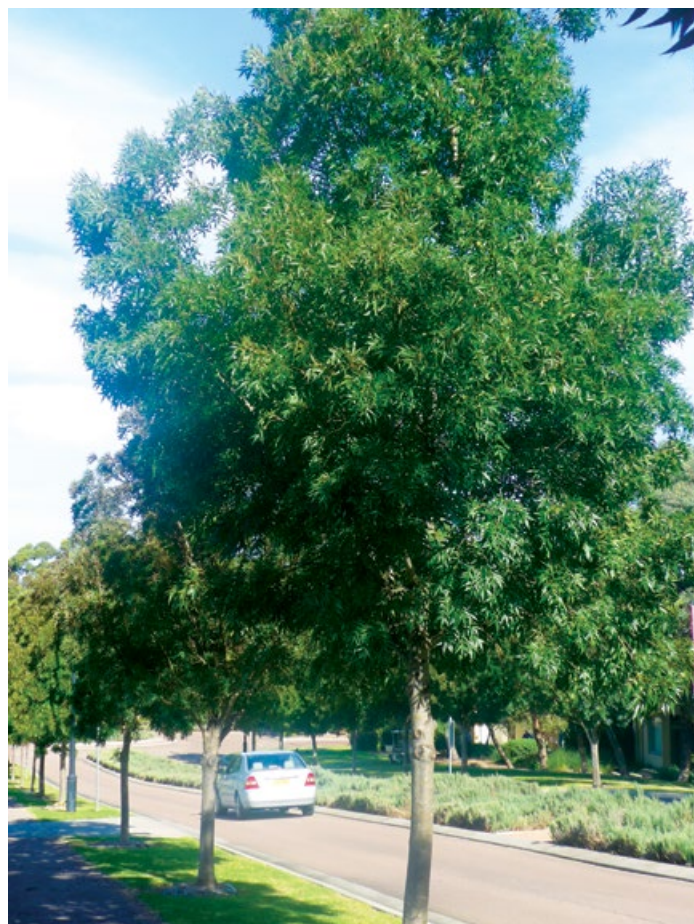
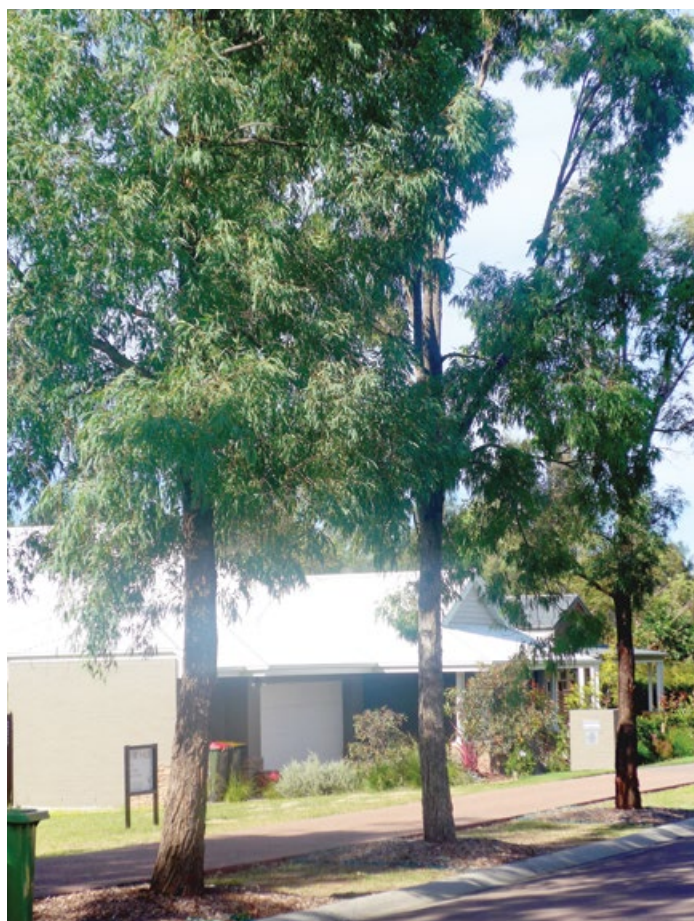
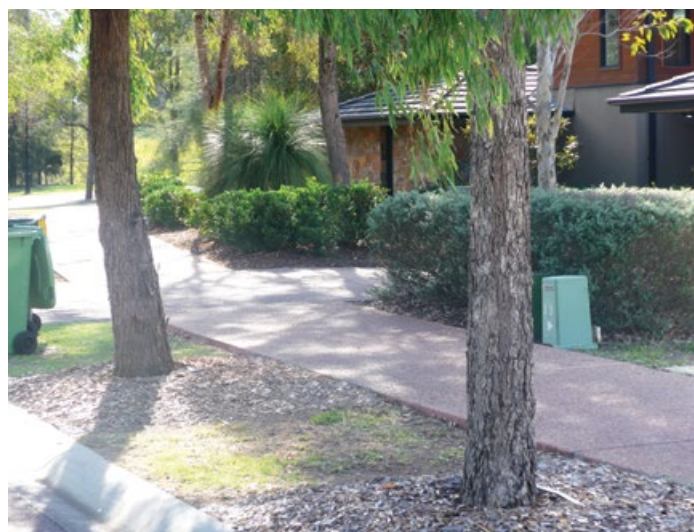
The new Citygreen root director C series carries the original benefits of the RD640 root director but now also includes an integrated circular lawn edge at the top surface for a neat finish to projects.

The Vintage Estate is a high class estate located in the Hunter Valley, NSW, Australia. Root directors were used in this estate and subsequently the trees have flourished.

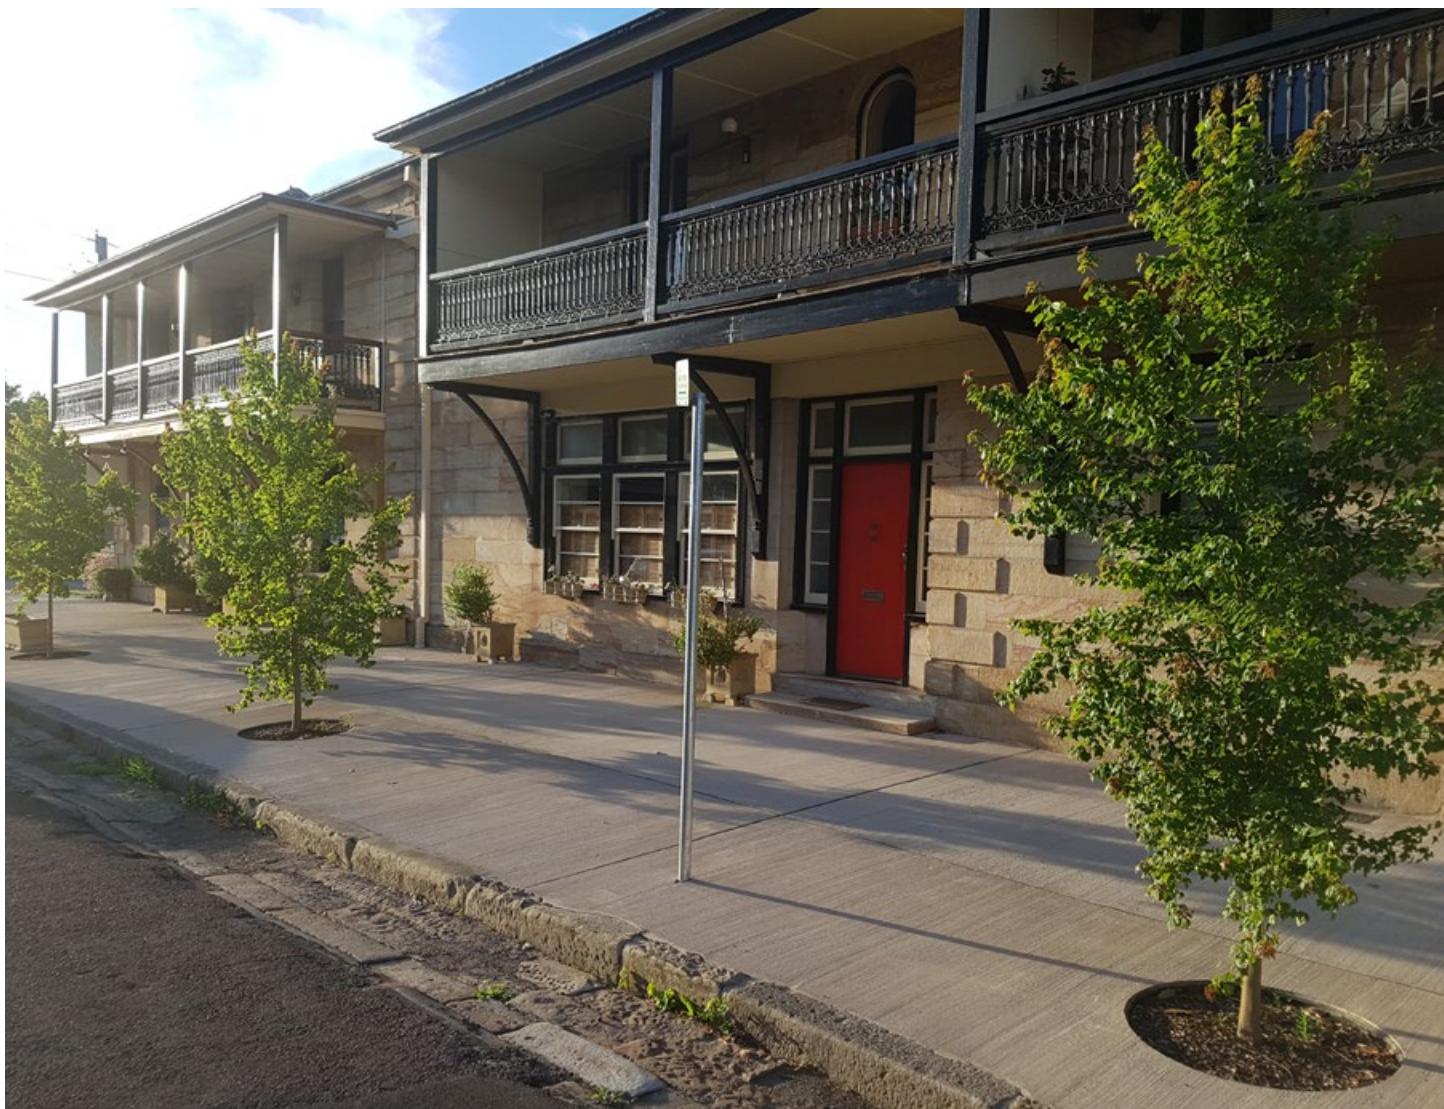
Root Directors used within a hardscaped area on Morphet's main street

Today, Morpeth continues to thrive with many visitors exploring the township each year. Maitland City Council is dedicated to preserving the town for generations to come and has recently planted some new street trees using Citygreen's Root Director system. The council has leveraged this system for more than 20 years, enabling countless trees to thrive in close proximity to underground infrastructure and roadways by directing root growth downwards. In the latest installation at Morpeth, we see the new round Root Directors used within a hardscaped area, providing a neatly-rounded edge between the trees and the surrounding pavement. So far, the trees are performing well and should stand the test of time – like historic Morpeth itself.

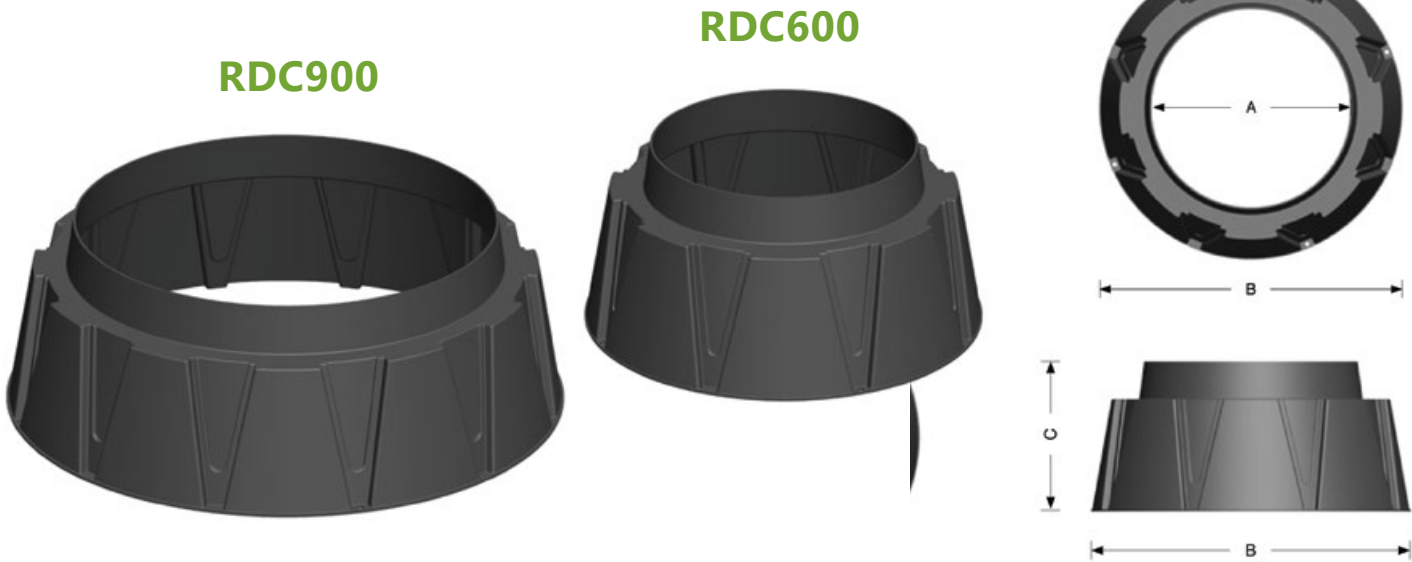
## Root Directors RDC 600 & 900

| Product Code | Dimension A (nom) | Dimension B (nom) | Dimension C (nom) |
| RDC600 | 600mm | 900mm | 400mm |
| RDC900 | 900mm | 1200mm | 400mm |
