Sidewalk and Roots: Mitigating the Conflict—*An Overview*

by Gordon Mann, Consulting Arborist, Mann Made Resources, Auburn, California

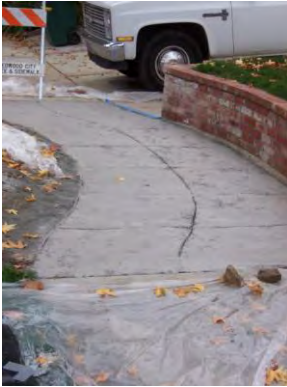
Poured in place rubber Sidewalk

Poured-in-Place Rubber – On the plus side, forms for this material may be removed after the product cures and it can be poured over roots. Other advantages are that it can be shaped or curved, can be placed in thinner sections (2 inch), it doesn't need a thick base, and the top surface can be colored for enhanced appearance. Disadvantages are that it is not reusable (no track record I am aware of), it is softer/more squishy than formed rubber panels (may be even softer in hotter climates), and its cost or contractor availability varies greatly by location. Another disadvantage is that most installations are not designed for vehicle traffic. This material is on the lower end of the thickness scale.

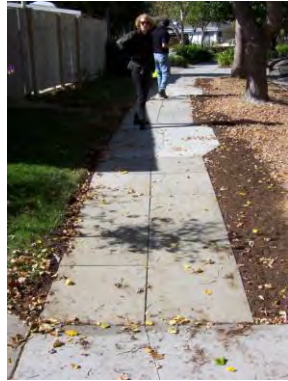
Rubber Panel Installation

Rubber Panels - On the plus side, rubber panels are made from recycled materials and are flexible, thin (around 2 inches), and re-usable. They can be cut to shape around trees and can be placed directly over roots. The base material can be filled in around roots and graded prior to laying the rubber panels. The panels have permeability in the seams between the panels. Also, rubber panels can be manufactured to have different finish appearances. On the minus side, an edge treatment is needed and if the final grade undulates (as in rolling hills), its edges may not match perfectly. Another disadvantage is that most installations are not designed for vehicle traffic. This material is on the lower end of the thickness scale.

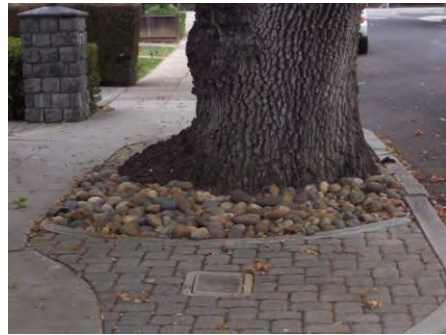
Roots offsetting curb and gutter; note: concrete edge band holding pavers

Interlocking Pavers – On the plus side, pavers are flexible, reusable, shape-able, and decorative, typically installed on a sand base that can be placed over roots. Pavers have permeability in the seams between the pavers. A disadvantage is that they need a concrete or rigid edge band on all sides to hold them in place and this band can be lifted by tree roots. They are mid to upper level on the thickness scale. Also, interlocking pavers usually require higher maintenance to keep them looking attractive.

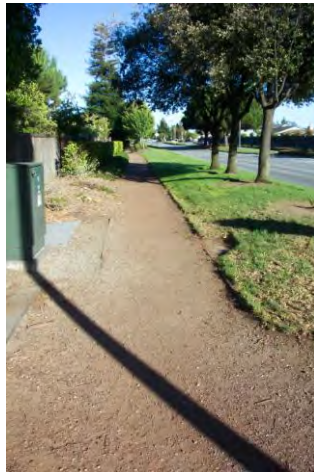
Decomposed Granite walkway

Decomposed Granite, aka Fine Rock Dust -This material is low cost and maintained by adding more or by re-grading. A binder can be used to help keep it together. Its border can be shaped, it can be laid over roots, and it doesn't need a deep base that can be placed over roots. On the minus side, it requires an edge band on the sides to hold it in place, and this band can be lifted by roots. Also, the surface needs more maintenance and it has the potential for dust to be tracked into homes and businesses. It can erode on slopes. The appearance may not be acceptable in some urban settings. This is mid to upper level on the thickness scale and once compacted is not very porous.

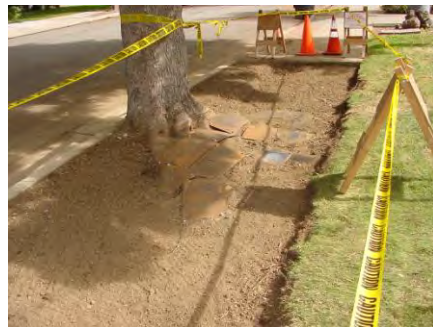
Sunnyvale, CA steel plates over roots

Sunnyvale's Steel Plates - An innovative method practiced for more than 15 years in Sunnyvale, California is to use steel plates to limit the future growth of the root towards the concrete improvement (see photo). Steel plates of 1/8" thickness are bolted on top of the root or placed on opposite sides of the root and bolted together, sandwiching the root. Future root growth cannot push the steel apart—rather, the root flattens between the plates. Plates are placed under or adjacent to the sidewalk to strategically limit future radial growth. This technique is more expensive than root pruning and it takes time to perform the plate work. However, Sunnyvale has not had to return to these sites for root conflicts and the trees are more stable than if they were root pruned.

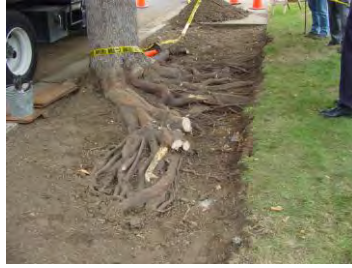
Selective root pruning,
Sunnyvale, CA

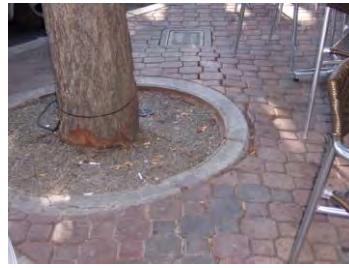
Concrete ring raised by roots
Trunk is large enough the grate was
replaced with DG

Tree Grates - Tree grates provide space around the tree as long as the grate opening doesn't cut into the trunk or trunk flare as the trees grow larger in girth. The opening can be enlarged by cutting the grate material but many cities fail to keep up with this requirement. Additionally, cutting the steel can rarely be completed on site. The grates offer permeability. On the downside, the grates must sit in a concrete footing. If the grate is 4 or 5 feet square, the space between the footing and trunk and roots is inadequate, and the grate frame is the first object to be lifted. Grates and installation are one of the most expensive treatments. If larger grates are used, 6' square, or 6' X 8' or 10', the soil area between the tree and the concrete frame footing may be adequate for long term growth, although larger grates are more expensive.

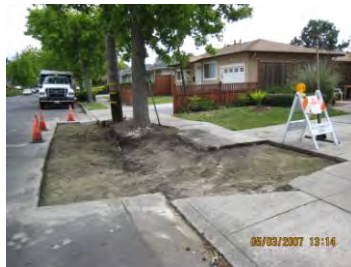
Large roots under sidewalk and
driveway

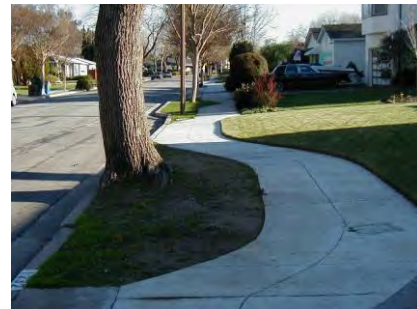
3 different sidewalk treatments; move away
from tree, move sidewalk next to curb, move
both sidewalk and curb away

- a) Planting new trees farther from the curb than the sidewalk (not just placing the tree in the center of a narrow planting strip); Trees can be planted inside the edge of the sidewalk using a half-grate or other temporary material until the sidewalk can be moved over later.
- b) Relocating sidewalks farther from the tree
- c) Relocating curbs farther from the tree
- d) Larger tree grate systems, moving the concrete footing farther from the tree
- e) Larger space around the tree/moving the concrete farther away in a downtown planting; the space can be filled with many of the materials listed above
- f) Removing the sidewalk on one side of a residential neighborhood street
- g) Obtaining easements to move sidewalks onto private property to provide more space for tree roots
